**STREAM RESTORATION PLAN  
FOR A 25-MILE SECTION OF THE  
LITTLE COAL RIVER  
LOCATED BETWEEN DANVILLE  
AND THE  
CONFLUENCE OF THE BIG COAL RIVER**

**R. E. I. CONSULTANTS, INCORPORATED  
225 INDUSTRIAL PARK ROAD  
BEAVER, WEST VIRGINIA 25813**

**31 AUGUST 2006**

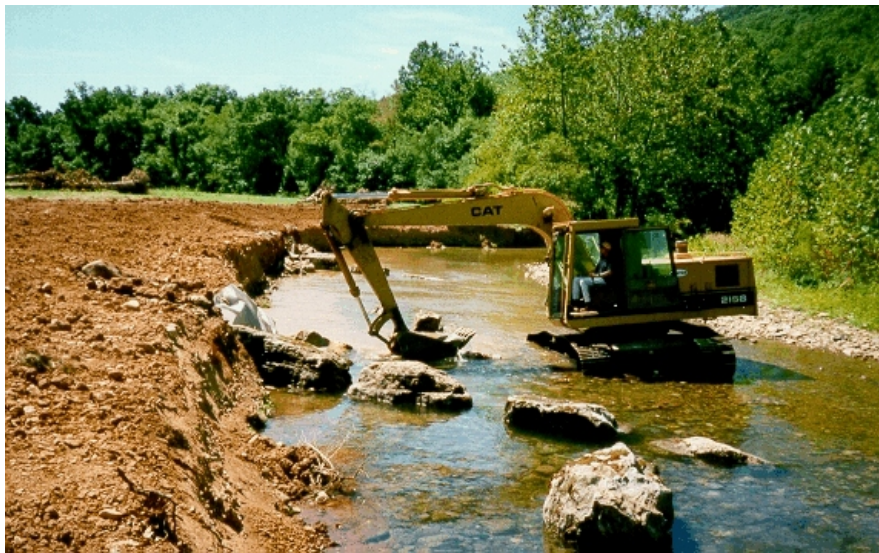
### A. SINGLE WING DEFLECTORS

Deflectors are intended to direct flow, create scouring pools, and provide instream cover for aquatic fauna such as fish and aquatic invertebrates, along with protecting unstable banks. Deflectors can be created out of either rock or log frames and filled tightly with smaller rock. Boulders are normally placed on the banks of both ends of the frame for further erosion control.

In the cobble and gravel sections of the Little Coal River reach, single wing deflectors and/or random boulder clusters will be beneficial to maintain flow in the thalweg, increase velocities, and form additional scour pools. Single wing deflectors also protect banks redirecting higher flows away from the banks, along with facilitate gravel deposition upstream enhancing fish habitat. The deflector or frame portion of the structure can consist of either a log or large rocks, like those used in the vane construction. When using logs, they should be firmly anchored into the bank a minimum of 5 to 6 feet. When two or more logs are used in a frame, they need to be firmly anchored to each other with rebar, driven through at least 4 inches and the rebar bent in the downstream direction. The deflector is extended to  $\frac{1}{2}$  the bankfull width, installed approximately at a 30 - 40 degrees from the bank, and installed on geotextile material since the majority of the substrate is sand. The logs then need secured to the bottom using 3 to 5 foot rebar pins spaced at 5 foot intervals. Larger stones are then placed at the connections on the outside of the frame for added stability and erosion control. Smaller stone can then be tightly packed into the frame deflector. If using rocks as the frame, 3 - 5 feet diameter rocks can be used, dense angular rock from 4 to 30 inches in diameter should be used for the fill material (MDE 2000).

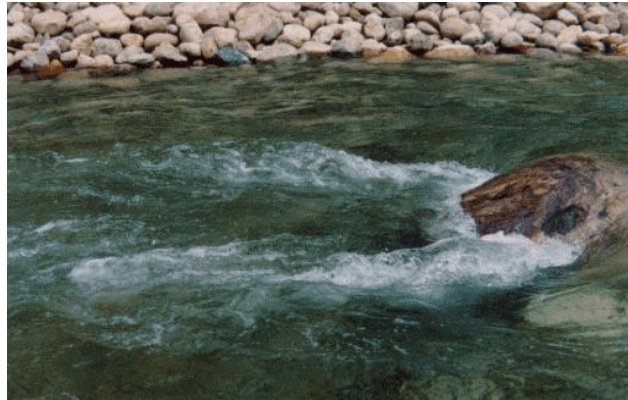
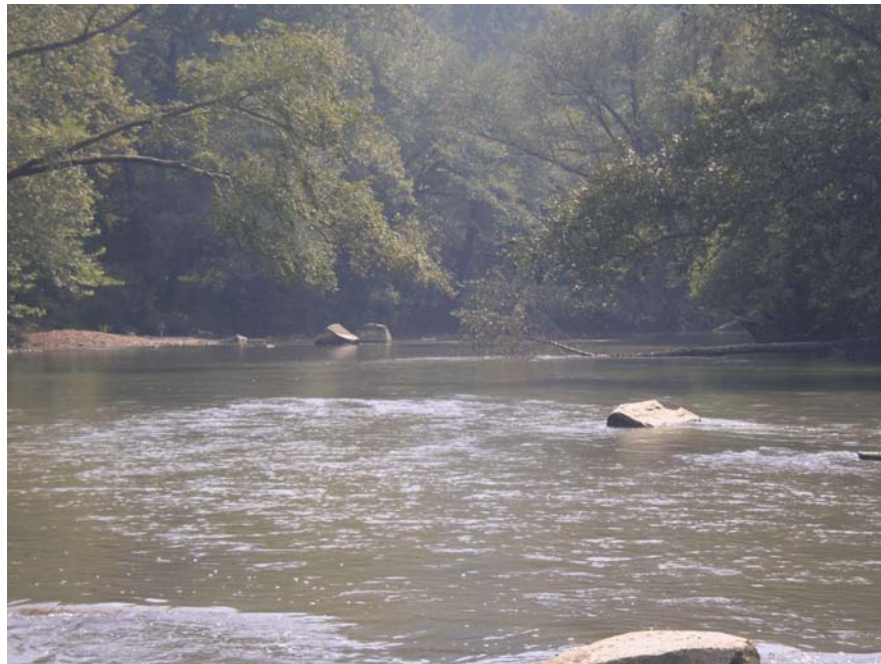
## B. RANDOM BOULDER CLUSTERS

By appropriately placing boulders, usually in riffles or guilds, increased velocities are generated to provide scouring pools (Orth & White, 1993). Depending on the stream size, boulders are usually three to five feet in diameter or larger. Boulders, along with logs, can also be placed along the channel banks to provide instream cover and pools, increase structural complexity, form substrates for invertebrates and fish, trap gravel for spawning habitats, organic matter supply, and increase channel stability (Orth & White, 1993). Bank revetments protect unstable banks deflecting high water velocities away from the bank. By placing boulders or other materials, including large woody debris, on the outside of meander bends, erosion on banks is decreased due to water being forced in front of the structures rather than behind or underneath them.

Random boulder placement and cluster boulder placement will create more profitable fisheries habitat and cover. By placing random boulders throughout Hopkins Fork, velocities will be increased to create scouring pools around the structures. These structures, normally range in size from 3 (minimum size) to 5 feet in diameter, can be of any shape (normally blocky and angular rather than round), and can be placed in groups, which normally provides more desirable habitats (FISRWG. 1998), or singly in a random manner (see PROPOSED HABITAT ENHANCEMENTS). When placed in groups or clusters, they will consist of 3 to 5 boulders and placed in a triangular manner (see DIAGRAM, MDE 2000). The boulder clusters will be spaced a minimum of 15 feet apart. The boulders will rest on top of footer rocks. However, the boulders will not be more than 25 to 30% of the bankfull depth after partial embedment (MDE 2000).

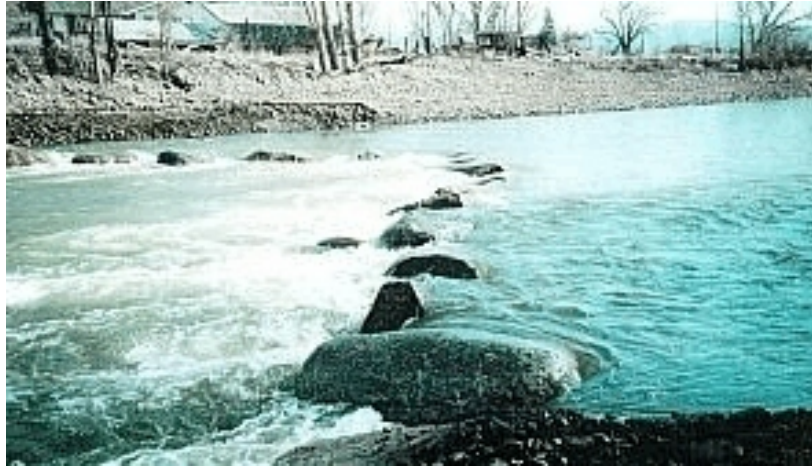
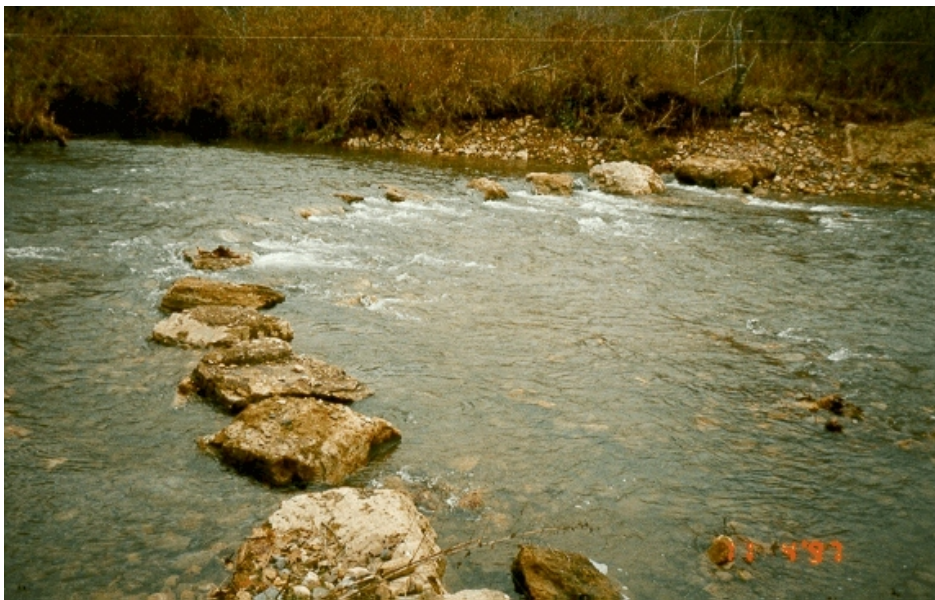
### C. CROSS VANES

Instream structures, such as cross vanes are normally used in larger order streams. These structures are used to protect banks, direct flow, regulate channel velocities, and produce scouring pools for fisheries resources. In addition to providing available instream habitat and cover, these structures provide improved recreational boating areas, and improved fish and benthic breeding substrates.

Traditional vanes will be constructed out of large, rounder-shaped, boulders approximately 3 (minimum size) - 5 feet in diameter, which are directed upstream lying against the flow. The vane portion of the cross vane and j-hook vane will occupy 1/3 of the bankfull width (approximately 10 feet) and the “hook” portion of the j-hook vane structure will contain 1/4 - 1/3 rock diameter gaps between the rocks. The vane of a rock vane occupies 2/3 of the

bankfull width and contains no “hook” or apex. The center or apex of the cross vane rocks will be at or near bed level to permit fish passage at low flows. The vane portion of the boulders will be angled between 20 - 30 degrees, measured from the tangent line where the vane intercepts the bank. Typically, the length of bank protected is approximately 2 times the length of the vane, or up to 3 times the length of the vane if the structures are a maximum spacing (Rosgen 2002a). The slope of the vane will be between 2 and 7 percent. The boulder structures will only extend to the bankfull stage elevation, therefore allowing water to pass freely over the structures. The top row of rocks will rest on top of footer rocks. Because the structures will be installed on a sand bed, extra footer rocks will be needed, which will also need to be installed on geotextile material. The footer will need to be installed first, which is normally, for sand, 6 times the protrusion height of the installed boulders (on cobble/gravel, 3 times the protrusion height of installed boulders).

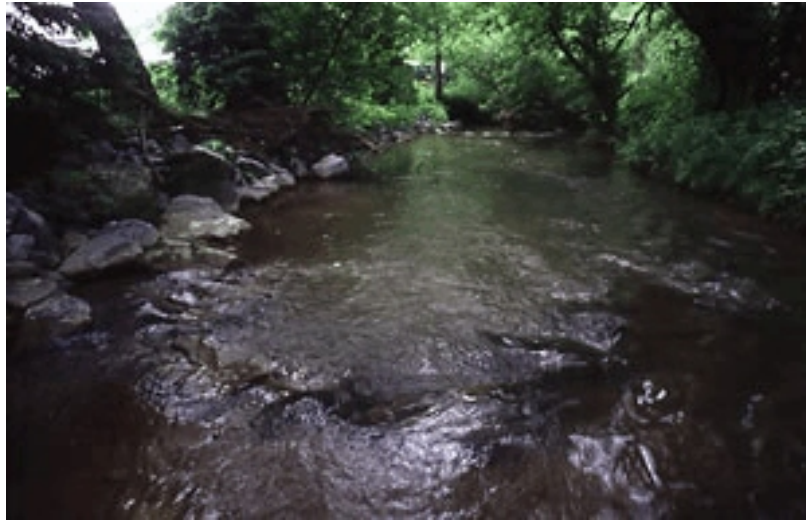
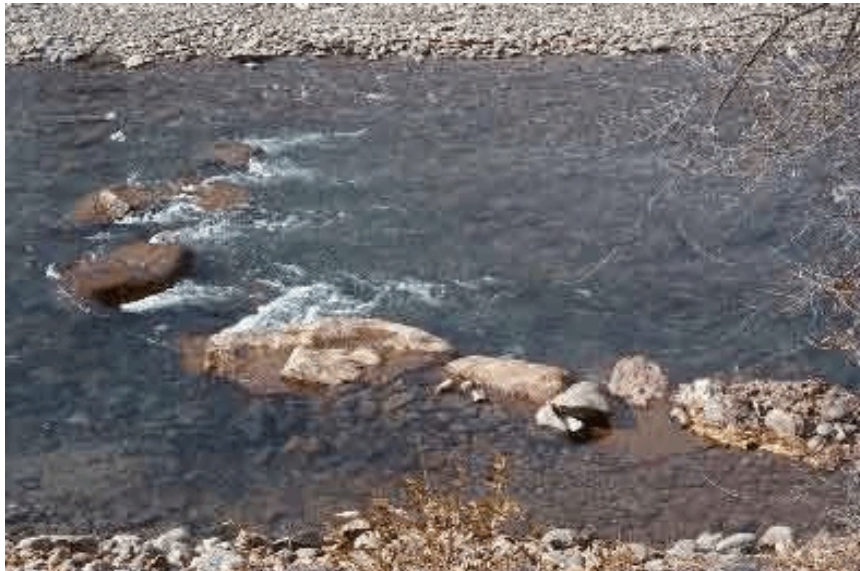
#### D. J-HOOK VANES

Instream structures, such as j-hook vanes, are normally used in larger order streams. These structures are used to protect banks, direct flow, regulate channel velocities, and produce scouring pools for fisheries resources. In addition to providing available instream habitat and cover, these structures provide improved recreational boating areas, and improved fish and benthic breeding substrates.

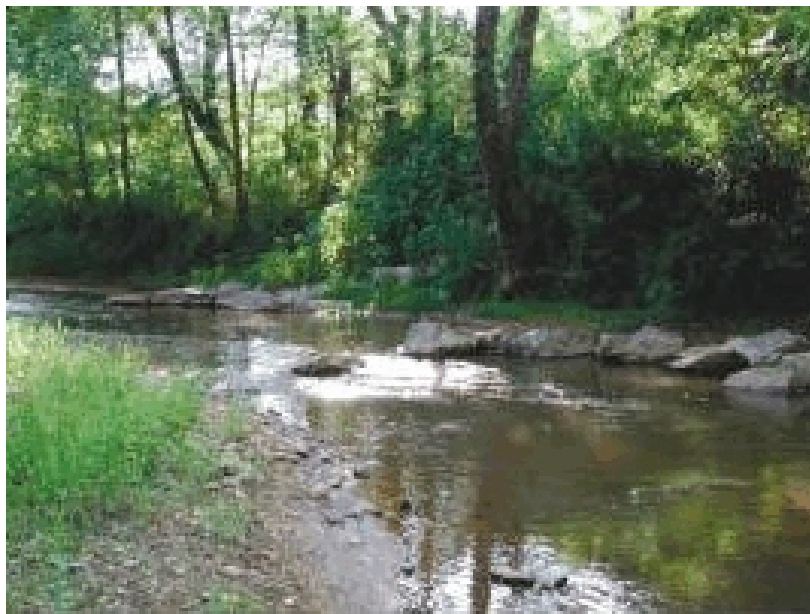
PLAN VIEW: ROCK VANE

Rock Vane & J-Hook Vane

Instream structures, such as rock vanes, are normally used in larger order streams. These structures are used to protect banks, direct flow, regulate channel velocities, and produce scouring pools for fisheries resources. In addition to providing available instream habitat and cover, these structures provide improved recreational boating areas, and improved fish and benthic breeding substrates.
